Inspection Report of Evaluation of Electric & Gas Service and HVAC Unit in New York
Multi-Unit Condominium

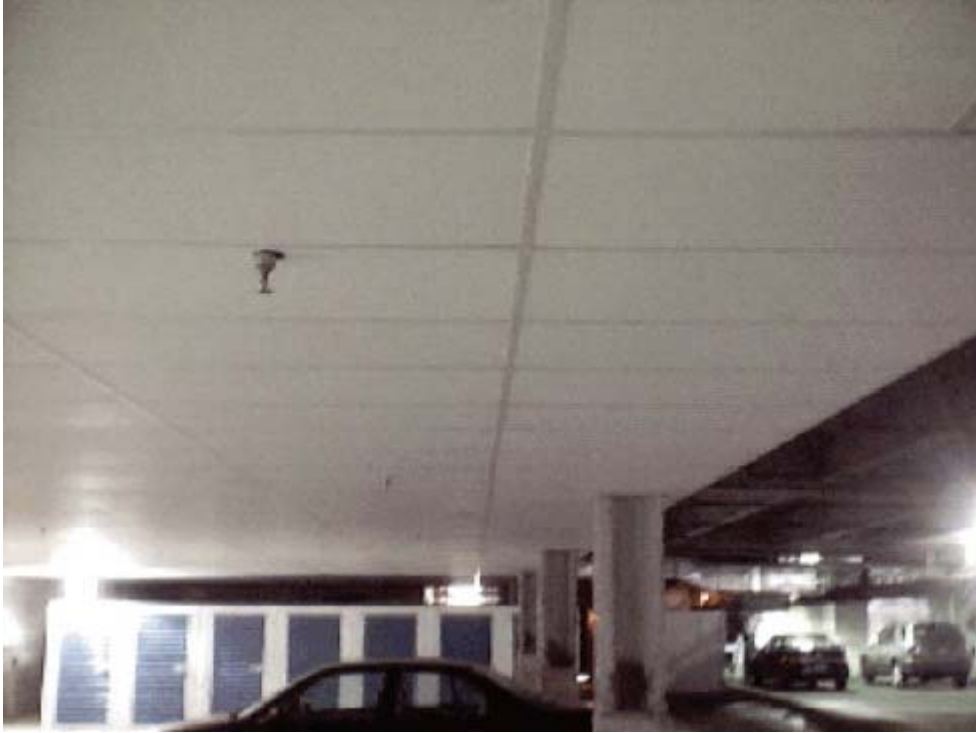
Photograph No. 1 - Fire sprinkler heads in the garage.

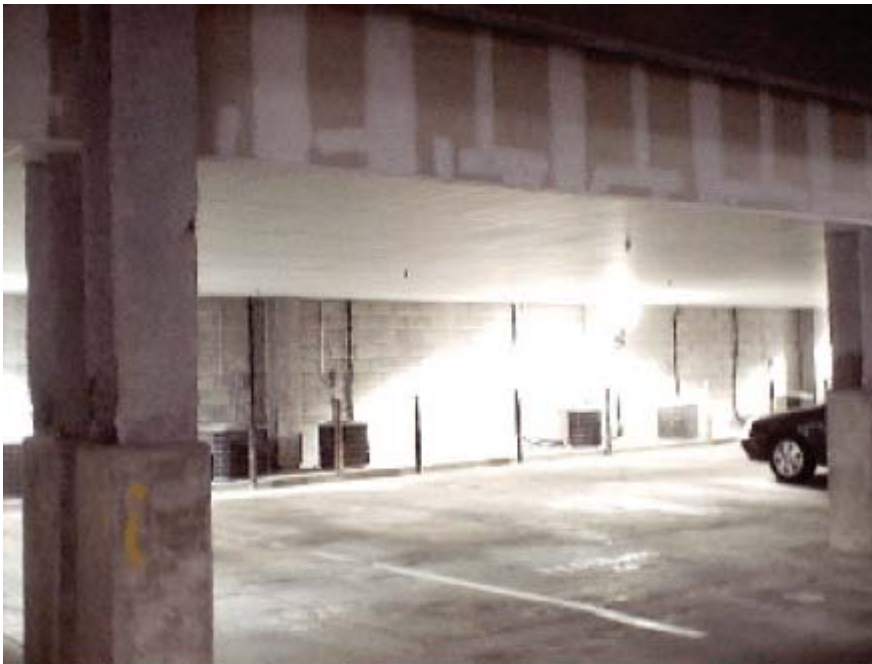
1. building elevator
2. condensing units associated with the HVAC units (Heating, Ventilation and Air-Conditioning) that serve the common areas only
3. various fans associated with these HVAC units
4. electrical heaters located in the following areas:
 - a. recycle room - 1 heater rated at 3.7 kW
 - b. garbage room - 1 heater rated at 3.7 kW
 - c. electrical room - 1 heater rated at 3.7 kW
 - d. fire pump room - 1 heater rated at 3.7 kW
 - e. sprinkler system in garage (plenum area) - 13 heaters rated at 3.7 kW each for a total of 48.1 kW (see Photographs 1, 2 and 3)

Photograph No. 2 - Garage Plenum where electric heaters are installed to prevent freezing of fire sprinkler system in the garage.

A more efficient heating system, such as the installation of a small boiler, to heat the electrical, fire pump, recycle and garbage rooms, and the sprinkler system in the garage would have been more economical to operate, but more expensive to install.

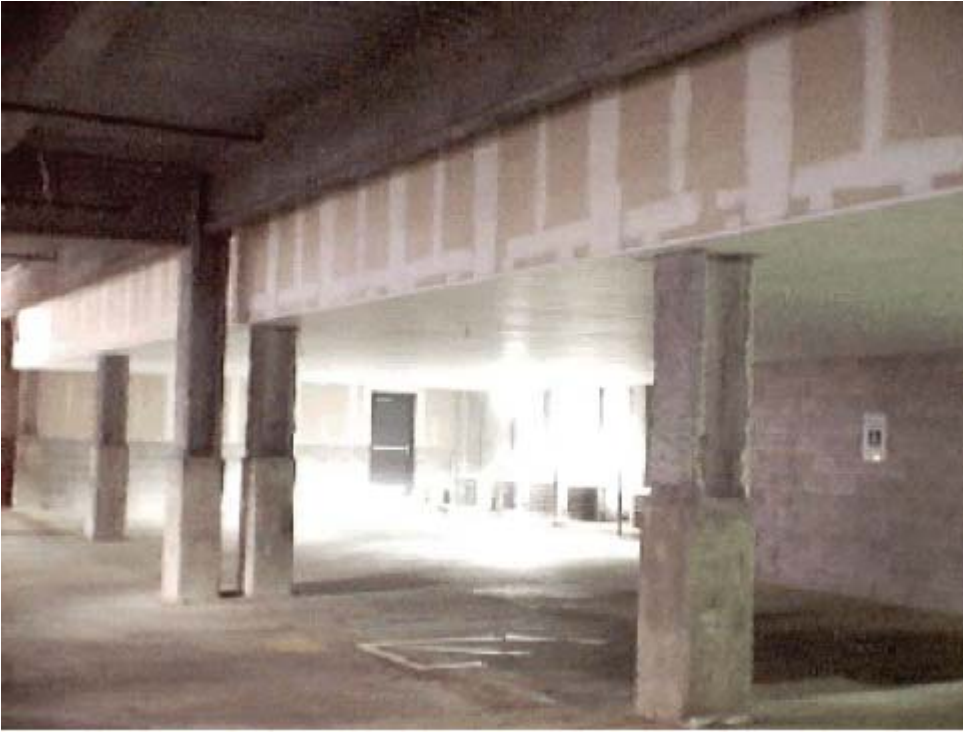
Photograph No. 3 - Garage Plenum where electric heaters are installed to prevent freezing of fire sprinkler system in the garage.
